# AI-Enhanced Condition Monitoring of Railway Infrastructure Using Onboard and Wayside Systems

**Diogo Ribeiro** ([dr@isep.ipp.pt](mailto:dr@isep.ipp.pt)), Túlio Bittencourt, Rafael Holdorf,  
Cecília Vale, Araliya Mosleh, Pedro Montenegro, Cássio Bragança,  
Thiago Fernandes, Jorge Magalhães

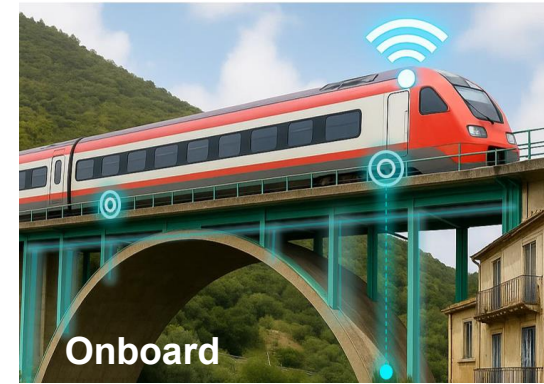
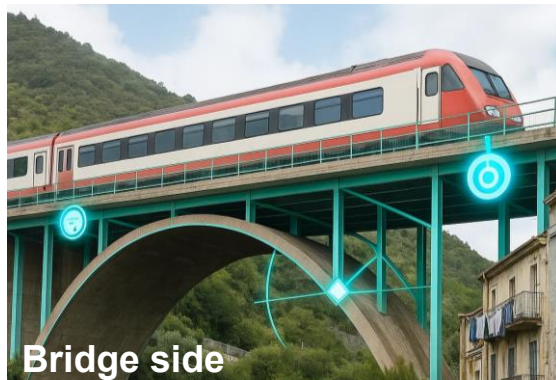
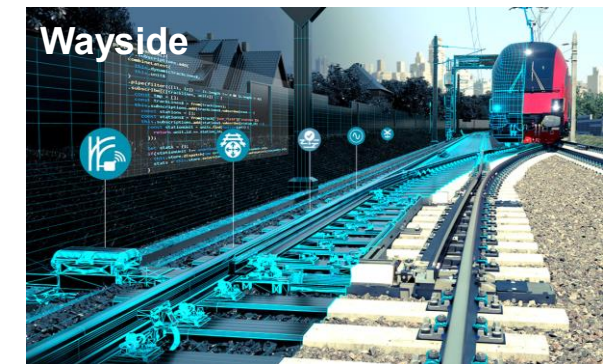
### Condition monitoring strategies

V2V (Vehicle-to-Vehicle)

V2I (Vehicle-to-Infrastructure)

I2V (Infrastructure-to-Vehicle)

I2I (Infrastructure-to-Infrastructure)

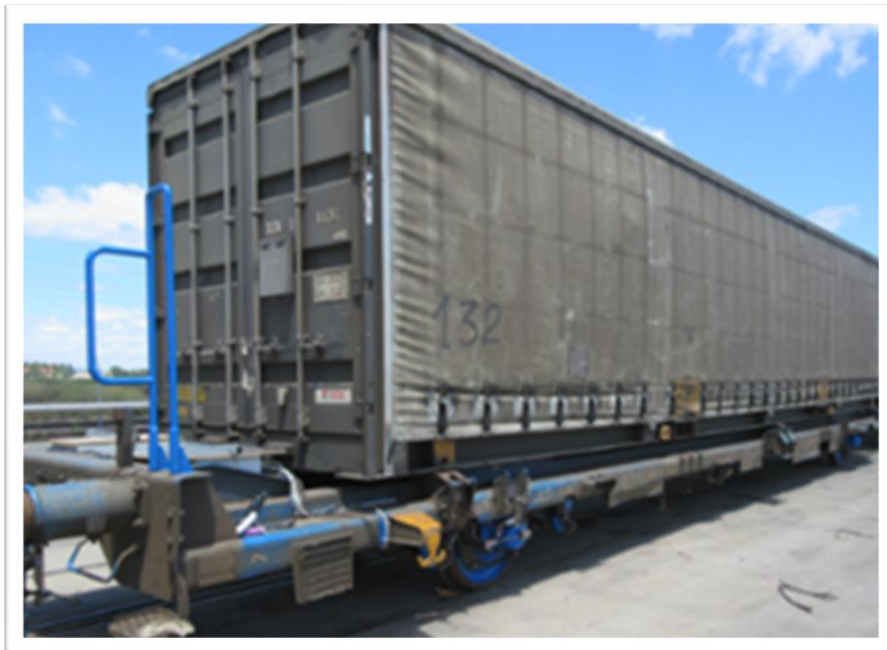
##### Freight vehicle

- Laargss freight wagon for container transportation
- Total length: 14.8 m
- 2-axes spacing 10 m
- 4-sets of progressive stiffness parabolic springs
- Max. load capacity: 52 t

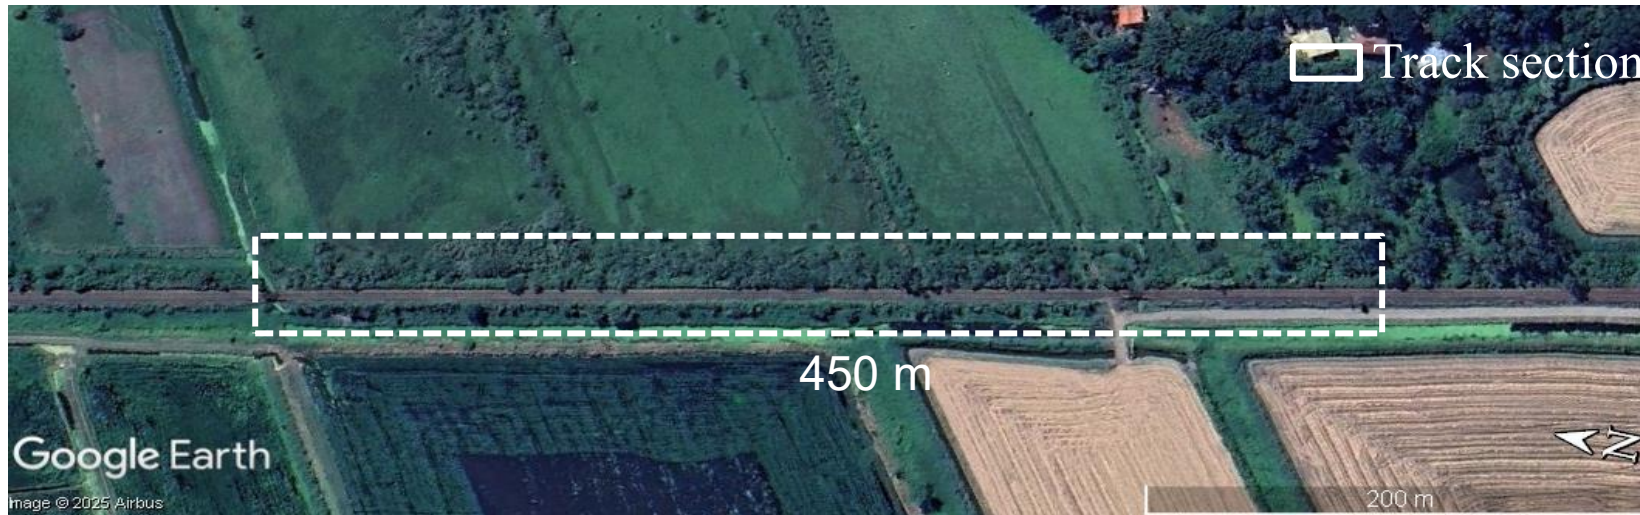
##### Track information

**Location:** South of Brazil  
**Built in:** 1953

**Gauge:** 1,000 mm  
**Sleepers:** Wooden  
**Foundation:** Ballasted track

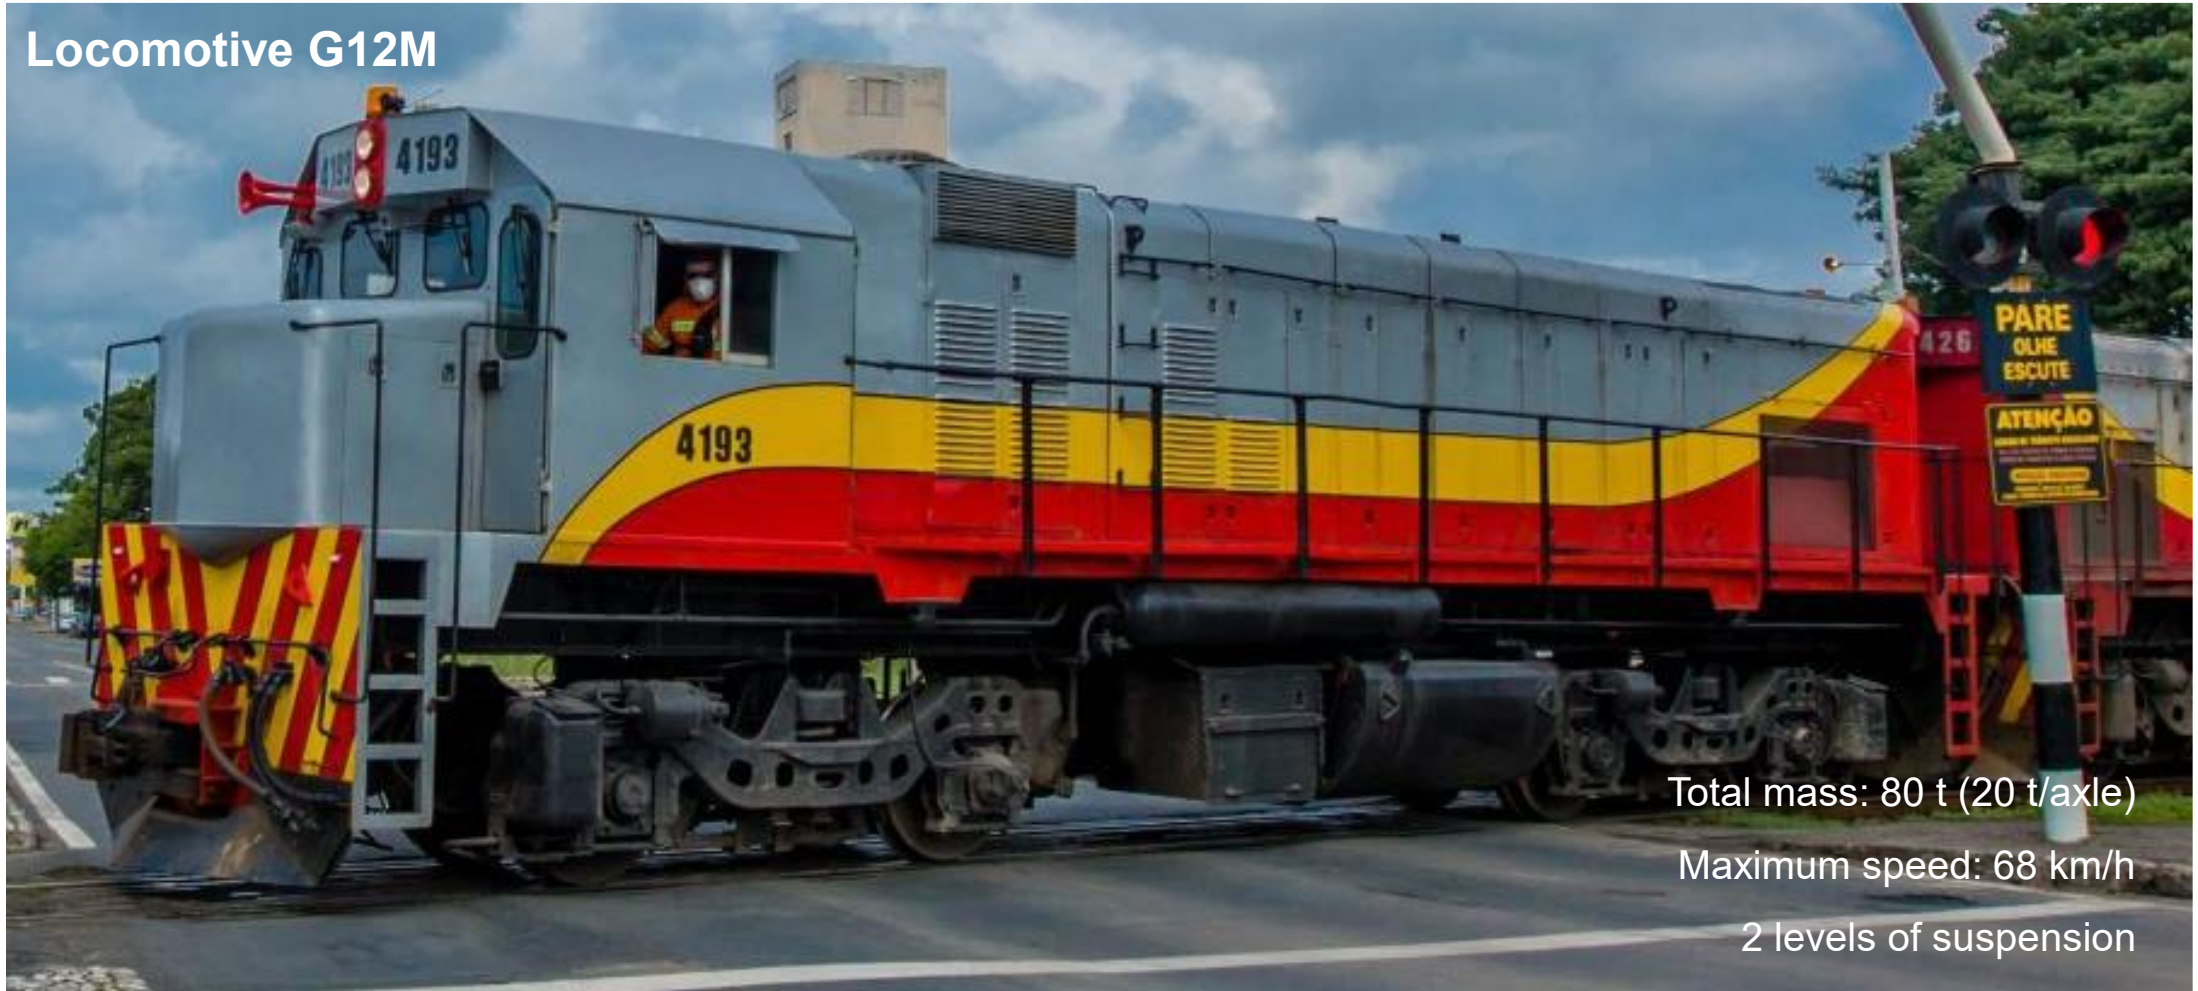
Locomotive G12M

Total mass: 80 t (20 t/axle)

Maximum speed: 68 km/h

2 levels of suspension

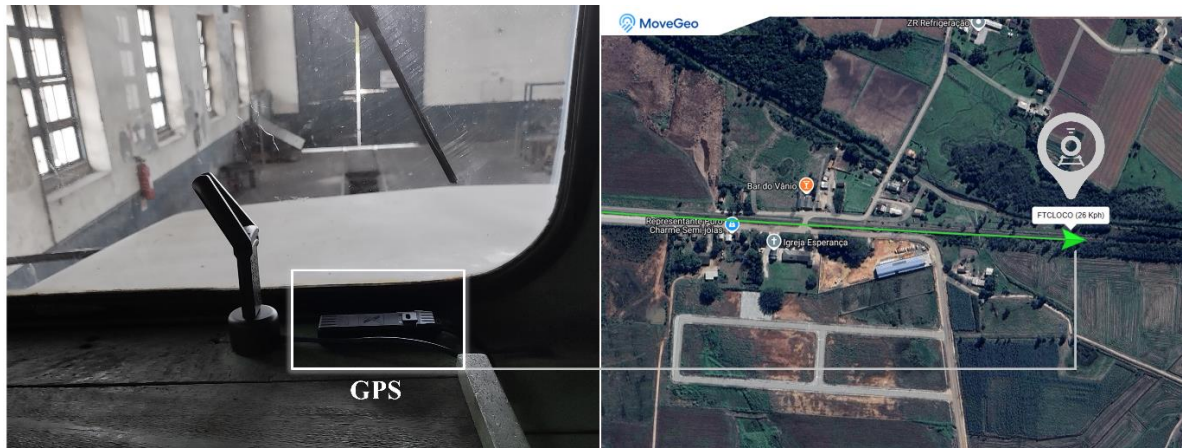
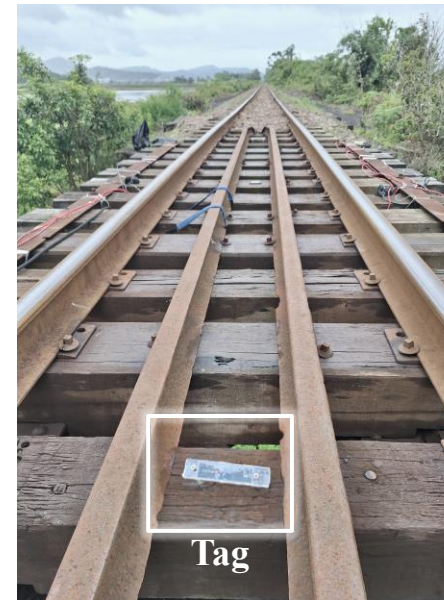
**Tracking system:** GPS

**Trigger system:** data logging & speed estimation

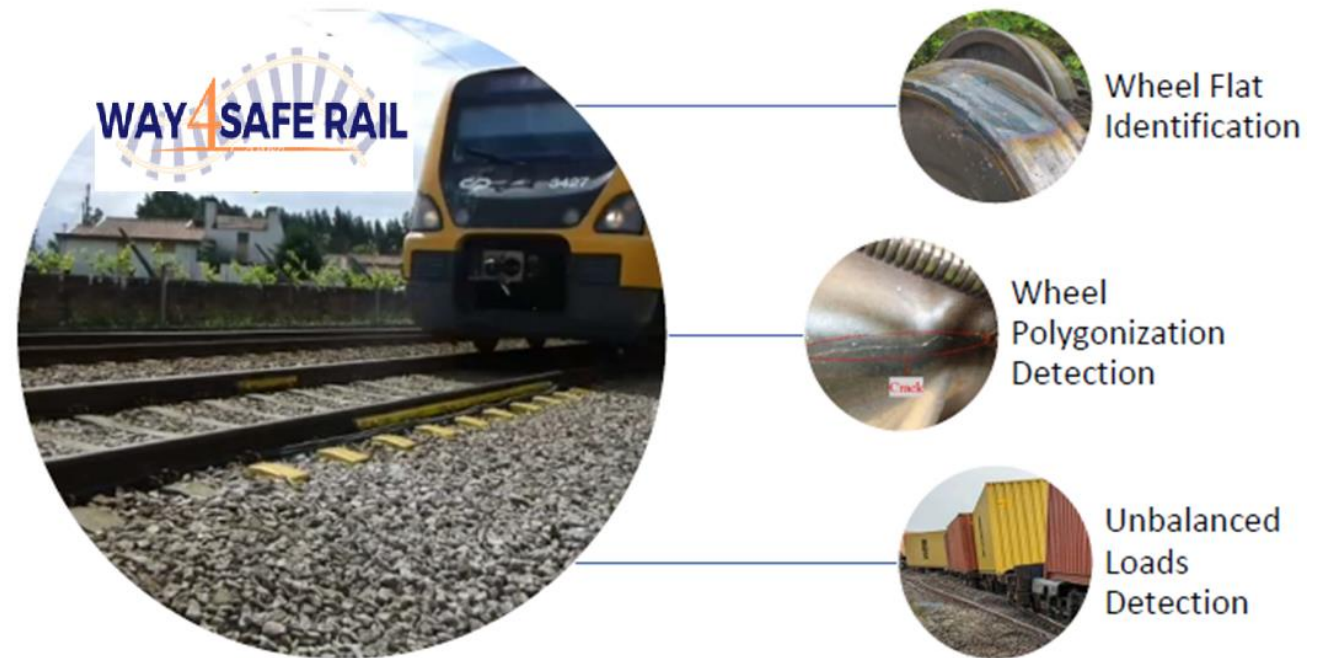
**Way4SafeRail** project envisage the **design of a I2V wayside monitoring system** capable of:

- i. assessing the **condition of the train wheels (flats and polygonization)** in operation, monitoring and categorizing their severity
- ii. detecting situations of instability in railway circulation, particularly **unbalanced loads**

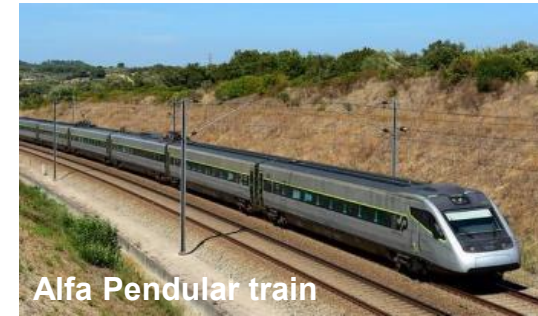
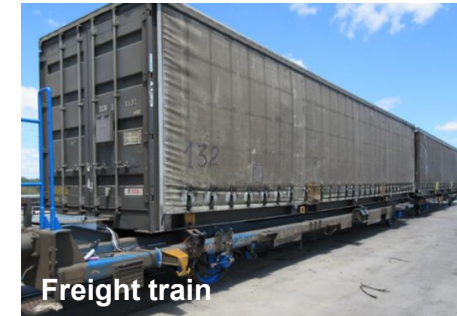
### VSI | Vehicle-Structure Interaction

**Models  
experimentally  
calibrated**

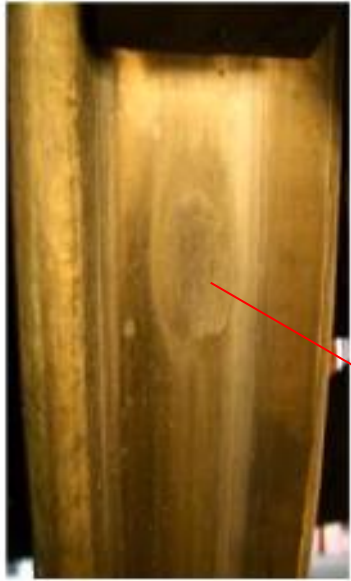
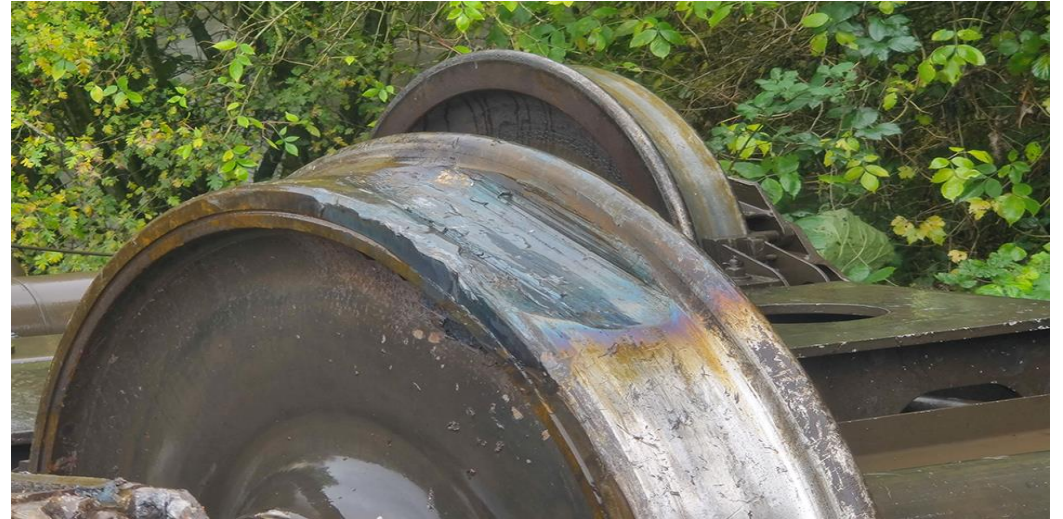
**Wheel flat** is a common tread defect mainly caused by repeated wheel/rail abrasion during the braking and the rolling of wheels over a long period of time.

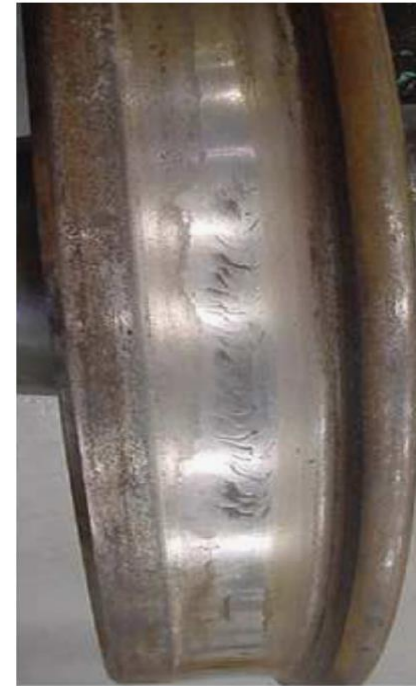
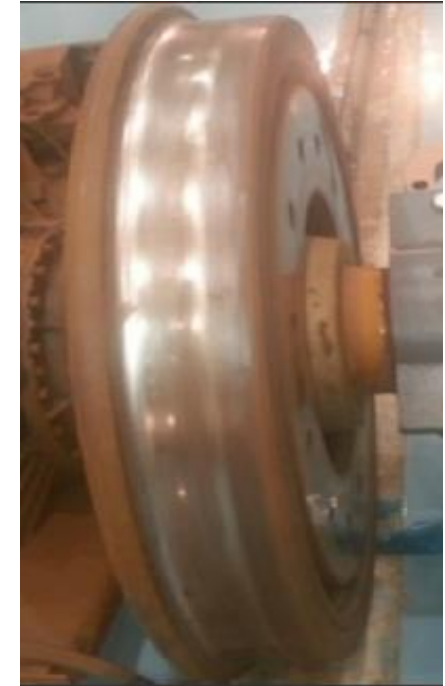
The **wheel polygonalization** is a periodic radial irregularity or wear around the wheel circumference with wavelength larger than 140 mm and amplitudes  $> 0.2$  mm.

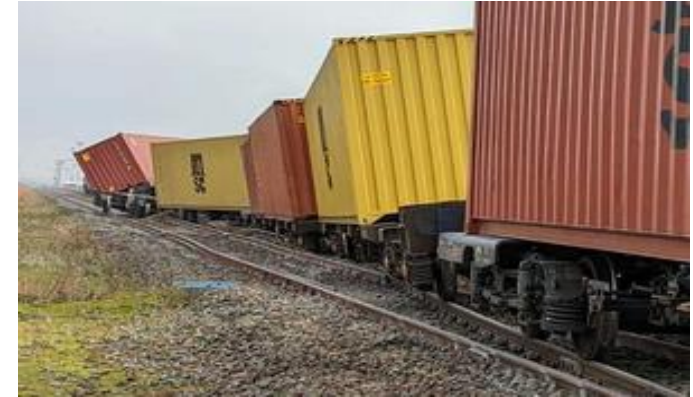
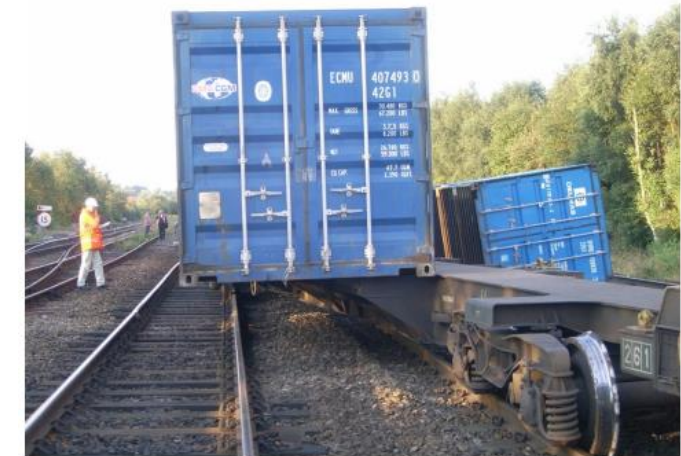
The presence of **unbalanced loads on freight trains** can potentially cause **higher levels of deterioration** or even the **failure of railway track components**, as well as **situations of risk of derailment**

For **2-axle wagons**: ratio of **2:1** between the masses per axle

For **all wagons**: ratio of masses per wheel: 1.25:1

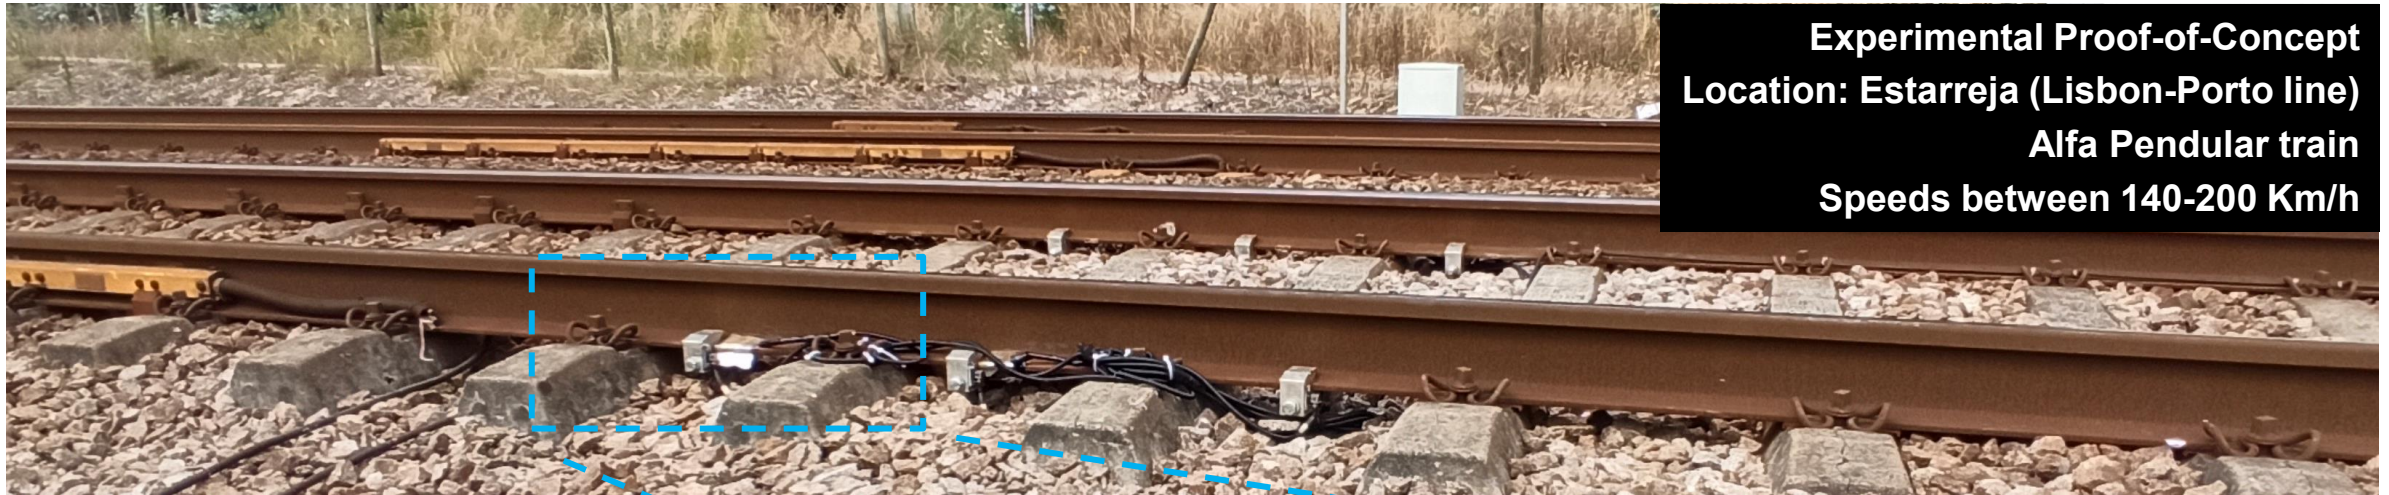
Experimental Proof-of-Concept  
Location: Estarreja (Lisbon-Porto line)  
Alfa Pendular train  
Speeds between 140-200 Km/h

6 Accelerometer ICP  
Model 356A02

4 Strain Gages  
LEA-06-W125E-350/3R

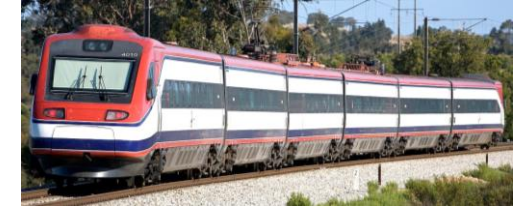
### Polygonalization classification: real-time online procedure

## Experimental campaign
